## Community Technical Support for Rebuilding After Cianjur Landslides Due to Earthquake 2022

<sup>1</sup>Department of Civil Engineering, Universitas Kristen Indonesia (UKI)

### ABSTRACT

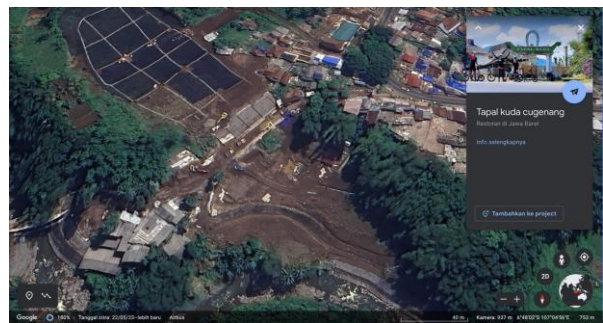
Figure 4. Location of the Cianjur horseshoe, West Java (source: Google Earth)

Human Activities The excavation and cutting of slopes are sometimes conducted without considering the underlying soil or rock layers and without incorporating slope stability studies. This oversight is particularly concerning in road building and other heavy-load construction activities. The drainage system is insufficient. A reservoir is located at the base of the incline, serving as a water source for the nearby military barracks (Figure 4).

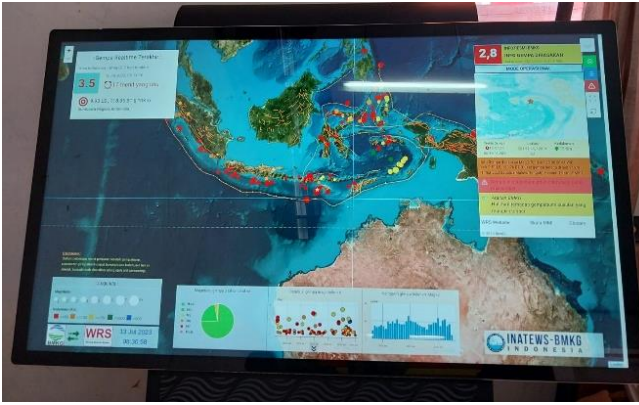
Earthquake **Figure 6.** Mapping of Disaster Zone after Cianjur

Prioritizing the identification and preparation of Cianjur's landslide-prone regions is essential for disaster management (Hutabarat et al., 2021). Before providing technical support information to communities, a team meeting with the Cianjur district's Housing, Settlement, and Land Service (PKPP) was conducted (Figures 5 & 6).
